Mars2020 Entry, Descent, and Landing Instrumentation 2 (MEDLI2) Do No Harm Test Series

**IPPW 14
June 12 - 16th, 2017**

Scope of Do No Harm (DNH) Testing

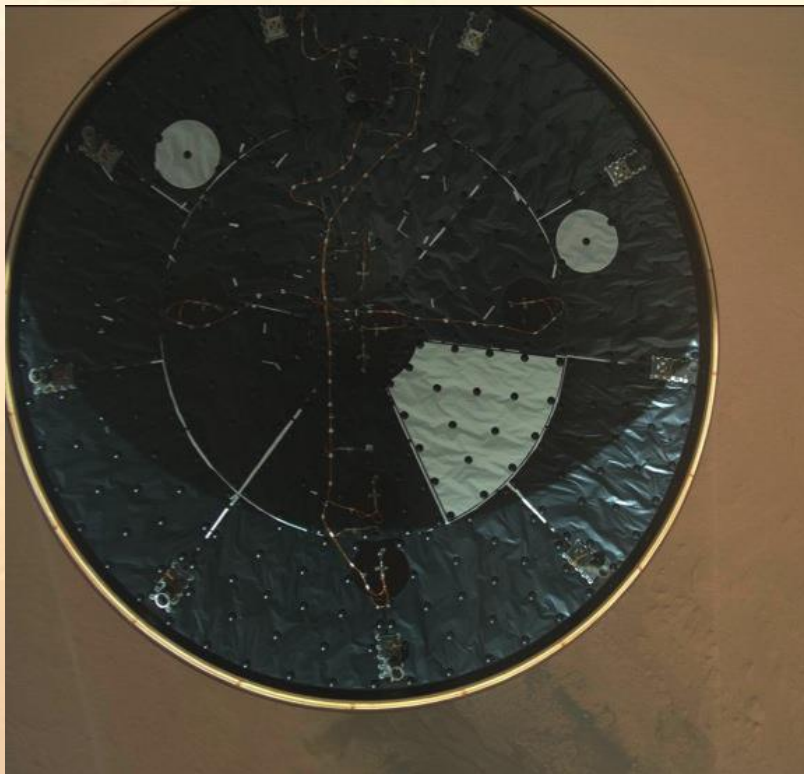
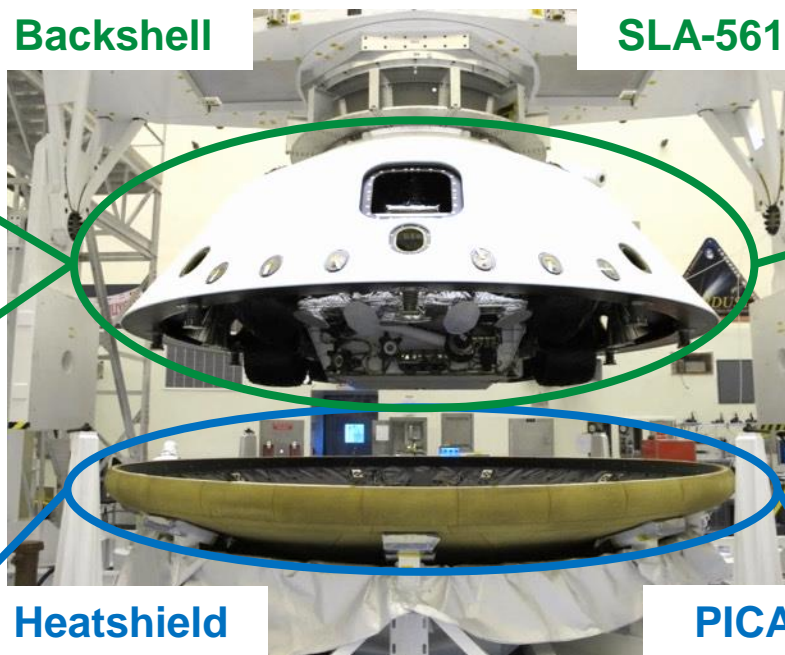
MEDLI2 complements and extends the measurements of MEDLI on the Mars Science Laboratory (MSL) with additional heatshield observation locations, inclusion of supersonic aerodynamics, and backshell aerothermal and pressure observations.

6 MEDLI2 Instrumented Sensor Plug (MISP)

- 5 Plugs: 1 TC
- 1 Plug: 2 TCs

3 Heat Flux Sensors

- 2 Total
- 1 Radiative

11 MISP

- 3 Plugs: 3 TCs
- 8 Plugs: 1 TC

Backshell

SLA-561V

Heatshield

PICA

Mars Entry Atmospheric Data System (MEADS)

- One Base Pressure Transducer (PT)

MEADS

- 1 PT for Hypersonic
- 6 PTs for Supersonic

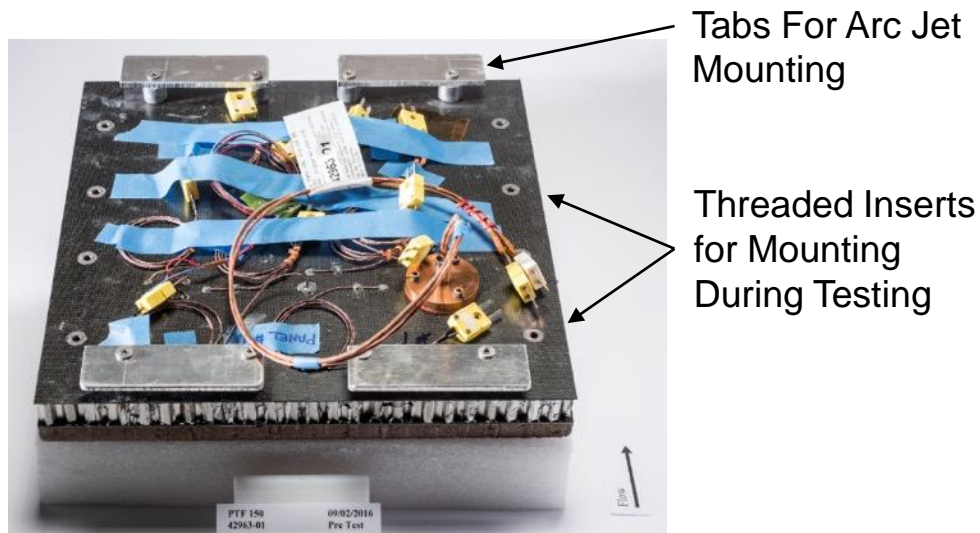
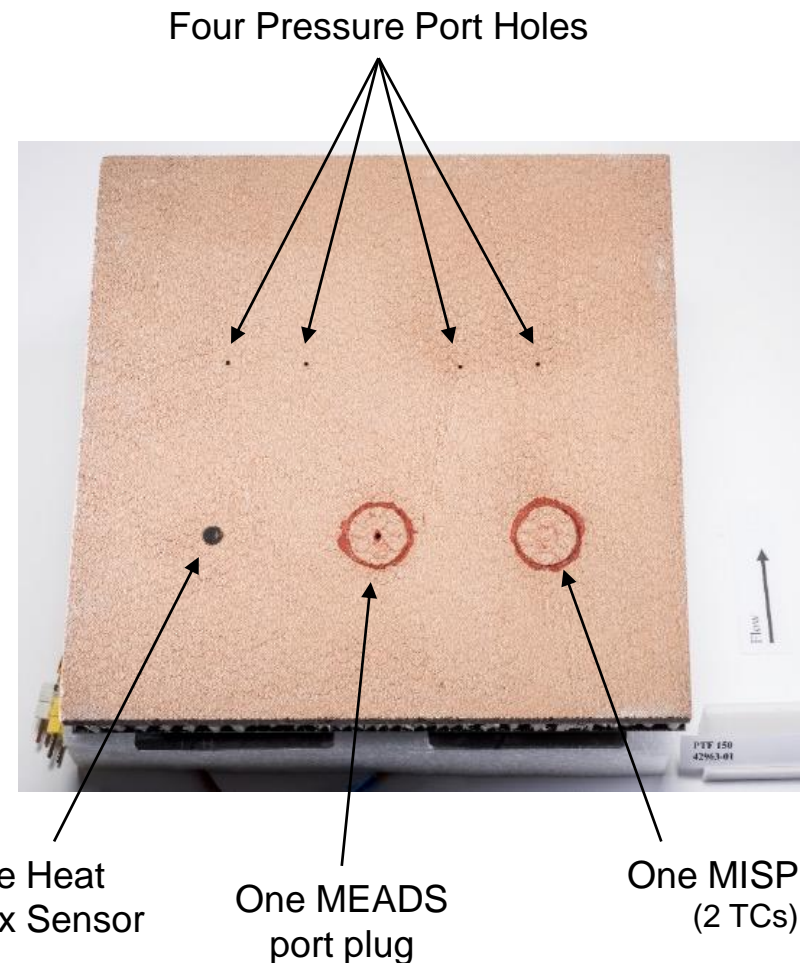
DNH Test Panel Design

- Four 12" x 12" SLA-561V Panel with Substructure
- Installed additional Thermocouples (TCs) at the bondline and backface after environmental testing for arc jet testing
- The four pressure port holes were located in specific proximities to the SLA-561V flexcore to examine the effect of the flexcore on the port hole (if any)
- The MEADS port plug was a mitigation concept if any issues were seen with port hole proximity to the flexcore

*All pressure ports are blind holes in the TPS, no active pressure measurements are present

- Pressure transducer port holes appear to be unaffected by proximity to SLA-561V cell walls
 - Laser scans show surface features at the sensor locations are all much less than 0.050"

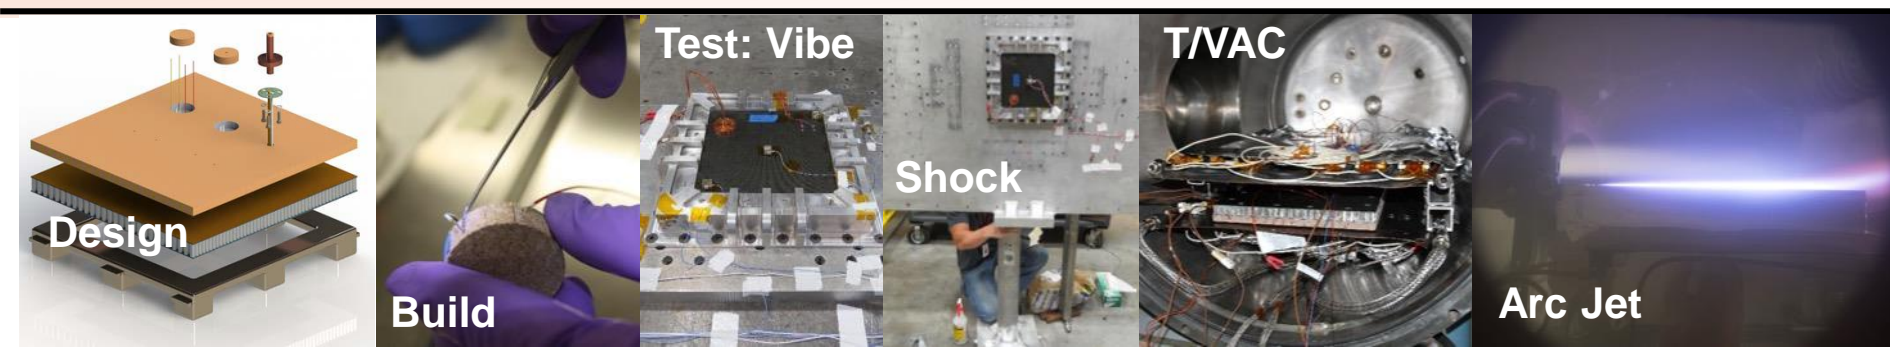
Do No Harm Test Series Sequence

➤ MEDLI2's Overall DNH Approach

- Build / procure flight-like backshell instrumentation
- Have Lockheed Martin develop and demonstrate backshell sensor integration on four flight-like TPS/substructure panels
- Expose the integrated panels to Mars 2020 qualification level environments (loads and durations)
- Expose the environmentally tested panels to worst-case simulated aeroheating in an arc jet
- Inspect and document the panels between each of the above tests
- One of four panels used as a control for the environmental testing

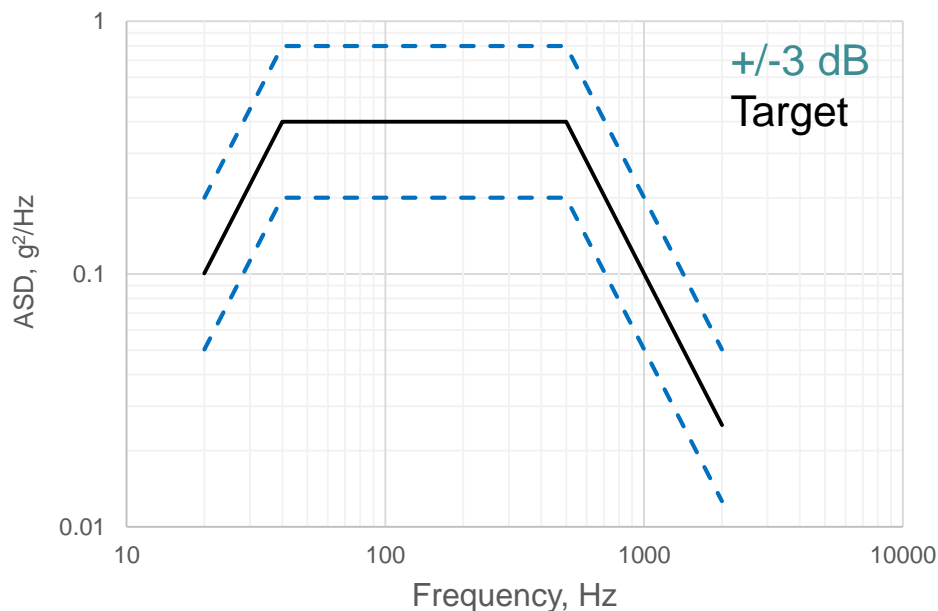
The acceleration spectral density (ASD) test levels for random vibration testing are taken from the Mars2020 Environmental Requirements Document and are detailed in “Qualification/Protoflight level” column below.

Vibrational Loads are derived from the expected Atlas V launch environment

Launch Random Vibration Profile		
Frequency (Hz)	Flight Acceptance Level	Qualification/Protoflight Level
20-40	+ 6 dB/oct	+ 6 dB/oct
40-500	0.2 g ² /Hz	0.4 g ² /Hz
500-2000	- 6 dB/oct	- 6 dB/oct
Overall	13.0 grms	18.4 grms

Overall Limits

Target: 18.4 grms
 +1dB: 23 grms
 -1dB: 14.65 grms

- Test in all 3-axes, two minutes per axis
- The ASD shall be within ± 3 dB over the 20-2000 Hz
- Overall spectrum level shall be within ± 1 dB of the specified rms level

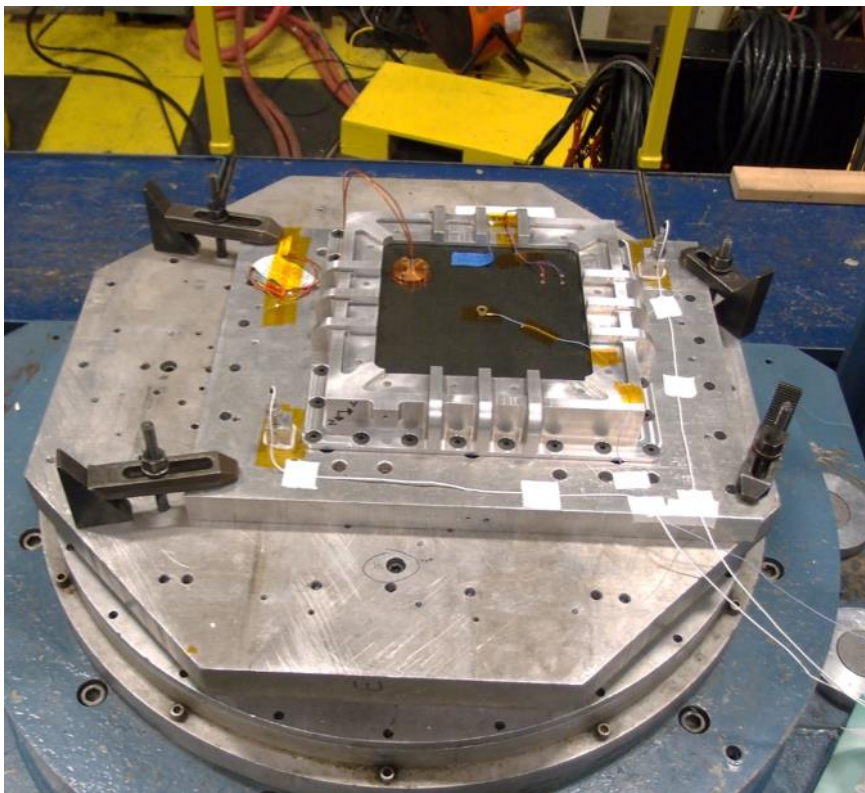
Z-Axis Setup

Random Vibration Test Setup

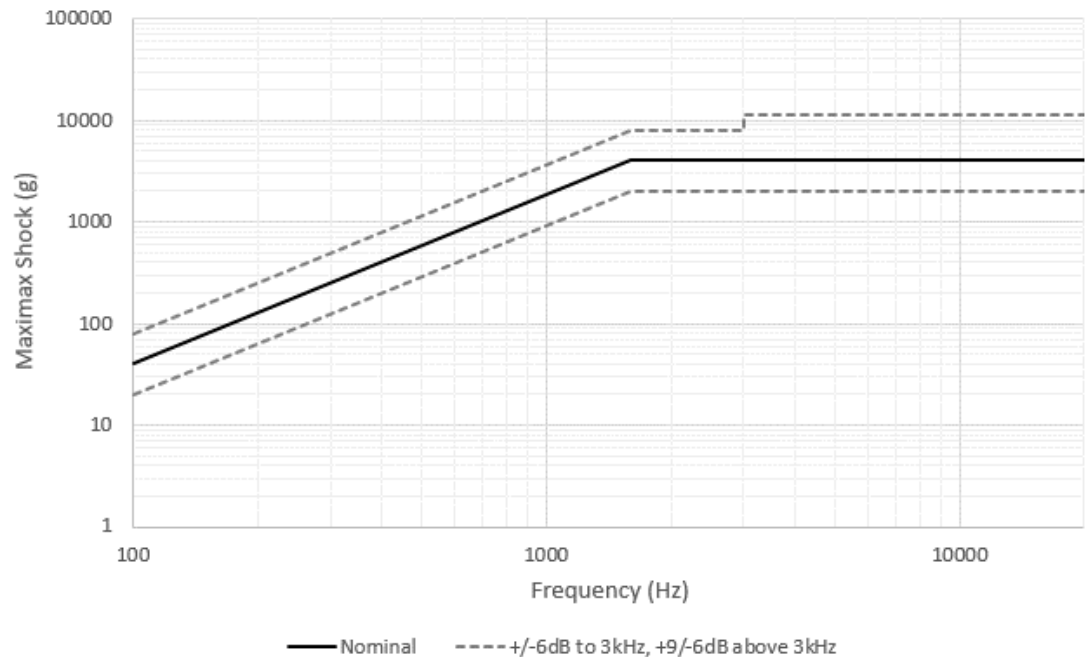
Shock loads are derived from the expected load of the ballast mass jettison event since many of the sensors are in close proximity

Frequency (Hz)	Level
100	40 g
100 - 1600	+10 dB/oct
1600 - 10000	4000 g

- Tolerance bands of +/- 6 dB to 3000 Hz, and +9/-6 dB above 3000 Hz
- At least 50% of the maximum spectrum values shall exceed the nominal
- Shock pulse should decay to less than 10% of its peak value within 20ms
- All 3-axes (x, y, and z) must be shocked, two shock per axis

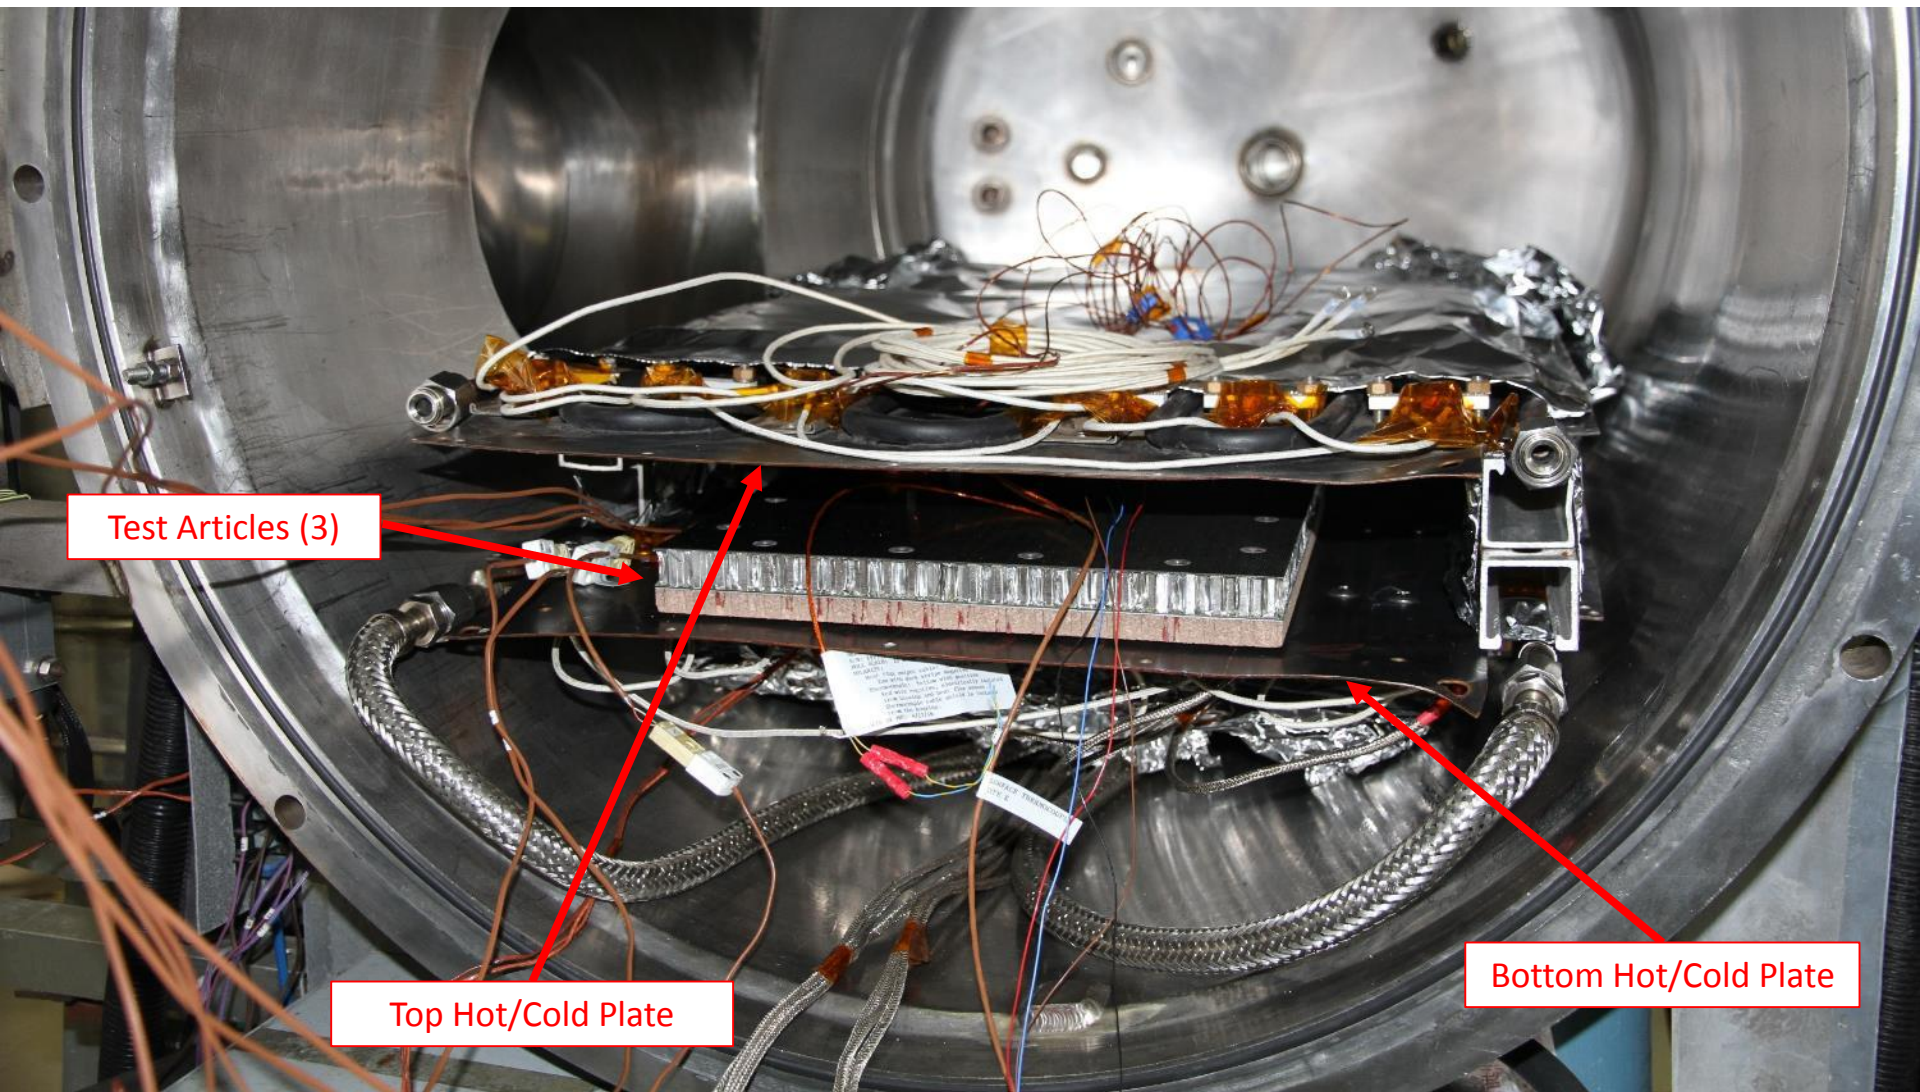
Thermal Vacuum Test Setup

Thermal loads are derived from the expected backshell worst case environments during the cruise phase

Condition No.	Phase	Target Temperature (°C)	Pressure (torr)	Dwell Time (minutes)
1	Check up	$T_{\text{room}} +5\text{ °C} / - 0\text{ °C}$	Ambient	60
2	Worst hot	$+77 \pm 2\text{ °C}$	$<10^{-5}\text{ Torr}$	180
3	Worst cold	$-140 \pm 2\text{ °C}$	$<10^{-5}\text{ Torr}$	180
4	Worst hot	$+77 \pm 2\text{ °C}$	$<10^{-5}\text{ Torr}$	180
5	Worst cold	$-140 \pm 2\text{ °C}$	$<10^{-5}\text{ Torr}$	180
6	Worst hot	$+77 \pm 2\text{ °C}$	$<10^{-5}\text{ Torr}$	180
7	Worst cold	$-140 \pm 2\text{ °C}$	$<10^{-5}\text{ Torr}$	180
8	Check up	$T_{\text{room}} +5\text{ °C} / - 0\text{ °C}$	$<10^{-5}\text{ Torr}$	60
9	Back fill	$T_{\text{room}} +5\text{ °C} / - 0\text{ °C}$	Ambient	-

- Test to be performed as specified in the table above
- Temperature ramp rate must be less than or equal to 5°C per minute when transitioning between test conditions
- Dwell time does not begin until all conditions are correct

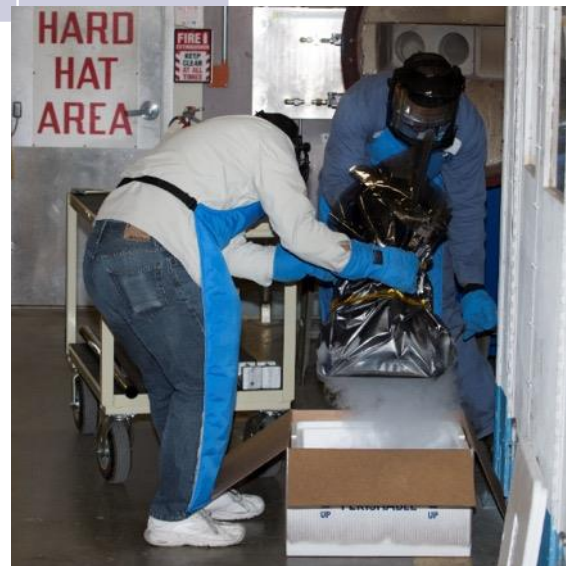
Run, Panel	Environmental Test			Target Arc Jet Conditions			
	Shock	Vibe	TVac	LN ₂ Cold Soak	Heat Flux (W/cm ²)	Exposure (sec)	Pressure (kPa)
Run 1 Panel 2	Y	Y	Y	N	8.2	110	<i>Best Effort</i>
Run 2 Panel 3	Y	Y	Y	Y	21.0	43	0.86
Run 3 Panel 1	Y	Y	Y	Y	21.0	43	0.86
Run 4 Panel 4	N	N	N	N	8.2	110	<i>Best Effort</i>

Cold Soak Performed Immediately Prior to Arc Jet Test providing Thermal Shock

- All 4 models successfully underwent arc jet testing
 - Two panels were thermally shock using a LN₂ bath prior to arc jet testing
- Overall panel and instrument Do No Harm performance was excellent

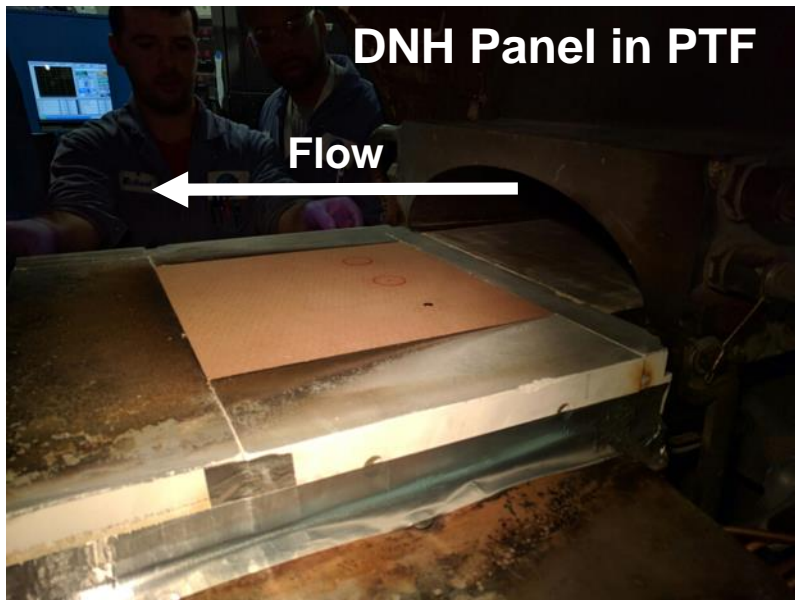
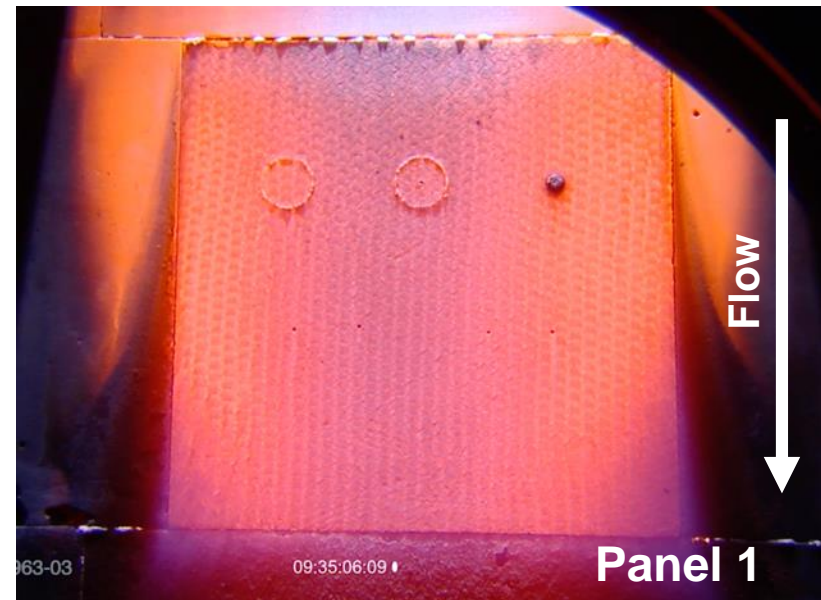
Do No Harm Arc Jet Summary

- MEDLI2 met targeted aerothermal test conditions (heatflux, heatload, pressure & shear) in the Ames Panel Test Facility (PTF)
- Inspection and analysis of test articles confirmed that MISP, pressure ports, and Heat Flux sensors did not cause degradation of the surrounding TPS
 - Laser scans show surface features at the sensor locations are all much less than 0.050"
 - All IML and bondline temperatures stayed below 150°C
- No observable difference between panels (Panels 1-3) and the control (Panel 4)

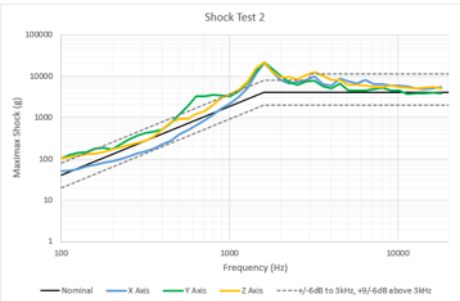
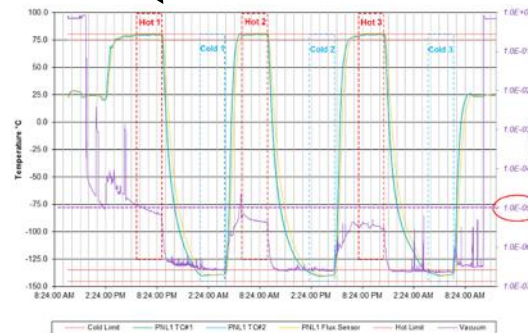
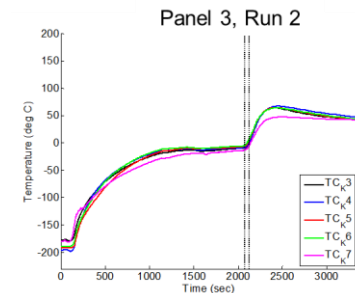
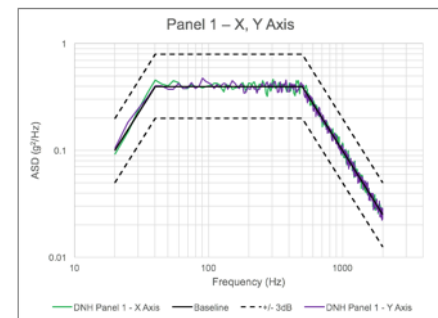
Test: Vibe

Overall 18.4 grms +/- 1 dB	ASD Profile +/- 3dB	Duration 2 mins per Axis
Panel 1, Z-axis	85.5 grms (overtest)	Overtest at 1k & 1.6kHz	2 mins
Panel 2, Z-axis	19.0 grms	Overtest at 1k & 1.6kHz	2 mins
Panel 3, Z-axis	18.9 grms	Overtest at 1k & 1.6kHz	2 mins
Panel 1, X-axis	18.4 grms	Within Limits	2 mins
Panel 1, Y-axis	18.3 grms	Within Limits	2 mins
Panel 2, X-axis	18.4 grms	Within Limits	2 mins
Panel 2, Y-axis	18.4 grms	Within Limits	2 mins
Panel 3, X-axis	18.5 grms	Within Limits	2 mins
Panel 3, Y-axis	18.5 grms	Within Limits	2 mins

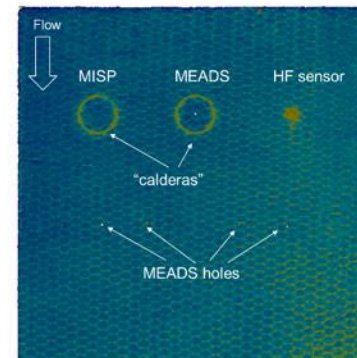
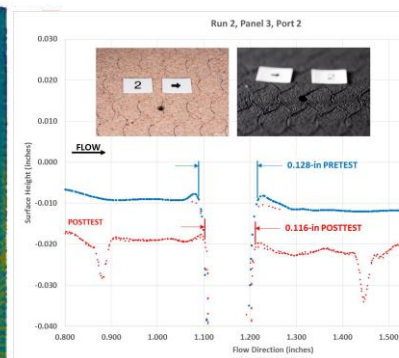
Shock Above Min			% Over Nominal			10% Decay Time		
	X-Axis	Y-Axis	Z-Axis	X-Axis	Y-Axis	Z-Axis	X-Axis	Y-Axis	Z-Axis
Panel 1, Shock 1	Yes	No	No	100%	17%	63%	21ms	15ms	15ms
Panel 1, Shock 2	Yes	Yes	Yes	63%	89%	100%	17ms	18ms	18ms
Panel 1, Shock 3	Yes	Yes	Yes	63%	100%	98%	15ms	17ms	18ms
Panel 2, Shock 4	Yes	Yes	Yes	61%	87%	76%	19ms	18ms	17ms
Panel 2, Shock 5	Yes	Yes	Yes	72%	85%	74%	19ms	24ms	19ms
Panel 3, Shock 6	Yes	Yes	Yes	61%	89%	91%	18ms	20ms	19ms
Panel 3, Shock 7	Yes	Yes	Yes	63%	96%	89%	17ms	17ms	16ms

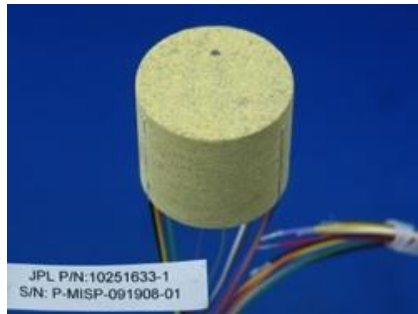
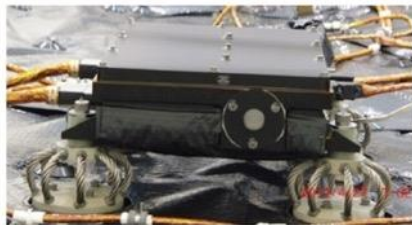
MEDLI on MSL (2012)

Heatshield

- 7 Pressure Transducers
- Hypersonic

- 7 Instrumented Plugs
- 4 TCs
 - 1 Isotherm Sensor

Sensor Support Electronics Box
